ALL THINGS WOOD

Anatomy of an Inherently Dangerous Deck

By Frank Woeste

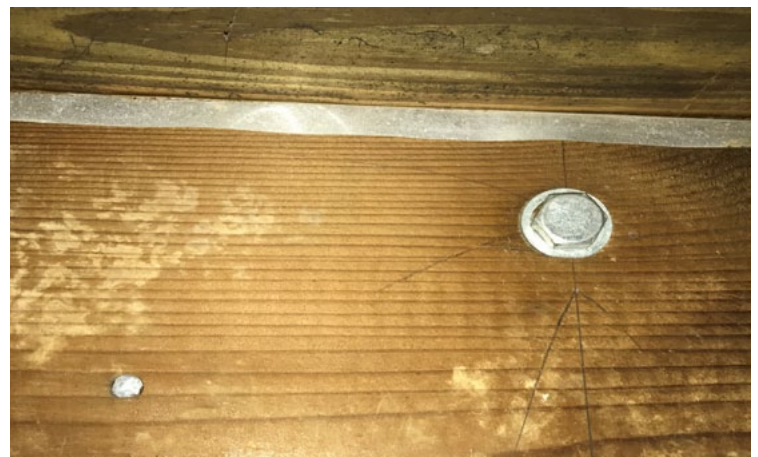
Figure 2. Section of a deck ledger with a nail head and ½” diameter lag screw installed.

The proper lag screw diameter per the IRC can be verified by the fact that 1/2" lag screws have a hex-head that is 3/4" wide. In this case, the contractor used 1/2" diameter lag screws to connect the ledger to the wall sheathing and house band. (The nail (bottom left) was likely used to position the ledger on the wall while the lag screws were installed.)

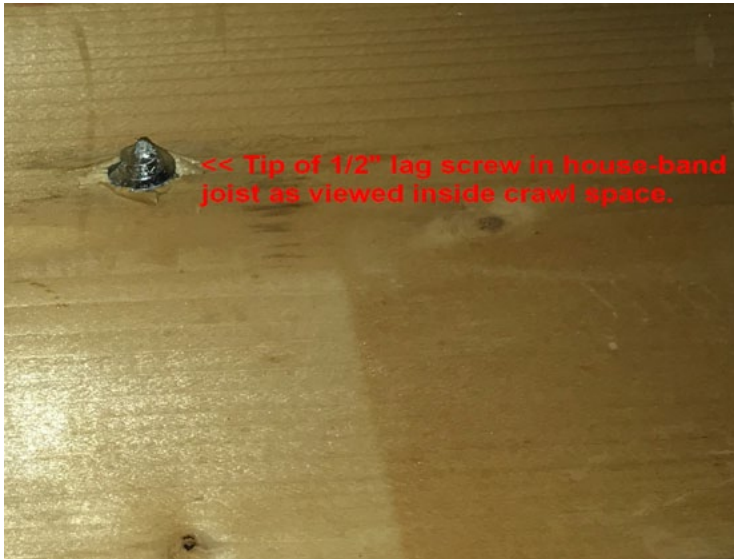
Figure 3. The tip of the lag screw depicted meets the IRC requirement for fully extending beyond the inside face of the band joist.

Because the tip of the screw extends beyond the inside face of the house-band joist, the installed 1/2" lag screw is clearly the proper length as required by the IRC. Assuming the tips of the lag screws are not present, the installation is not

IRC compliant and thus the deck may be unsafe, requiring an investigation by a design professional.
